# Technical Bulletin CS-08-03

SpectraLink Rev B Handsets (6020 / 8020 / 8030)

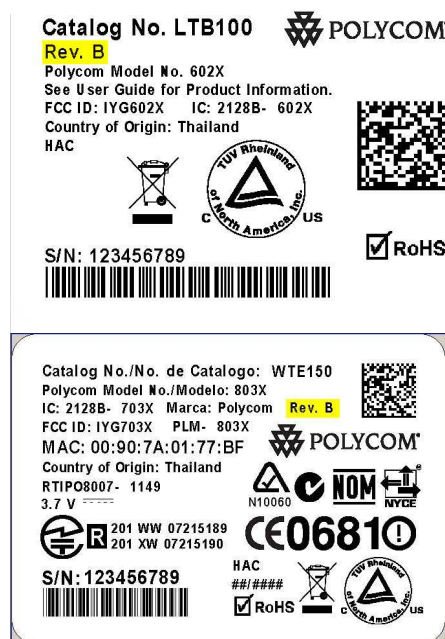
There has been an internal component change within the Link 6020 and the NetLink 8000 series handsets. While functionality has not changed, these phones will require a minimum version of software to operate. The hardware revision can be identified on the label on the back of the handset. The following diagram shows an example of how the label will appear. Specific handset models may vary, but they will be identified by the "Rev. B" indication as shown in the examples below.
