Software Upgrade of Polycom[®] RealPresence Trio[™] 8800 SKUs (-018) for Microsoft Lync

Engineering Advisory 111066

This engineering advisory explains an issue upgrading software on Polycom[®] RealPresence Trio[™] 8800 phones registering with Microsoft Lync Server.

This engineering advisory applies to RealPresence Trio 8800 phones with part number 2201-65290-018 running Polycom UC Software 5.4.0 Rev AA (5.4.0.12541) or earlier.

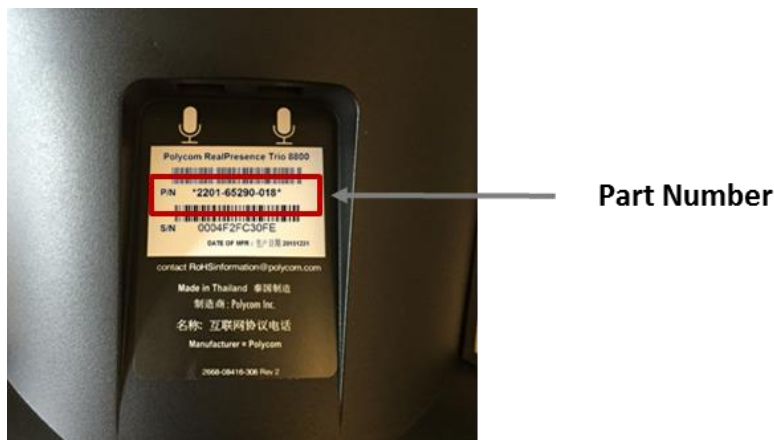
The phone's part number is located on the back of the phone, on the label with the bar codes, as shown next.
