Release Notes

Polycom® Video Border Proxy (VBP™) VOS Version 9.1.5.3

Introducing the Polycom VBP System Version 9.1.5.3

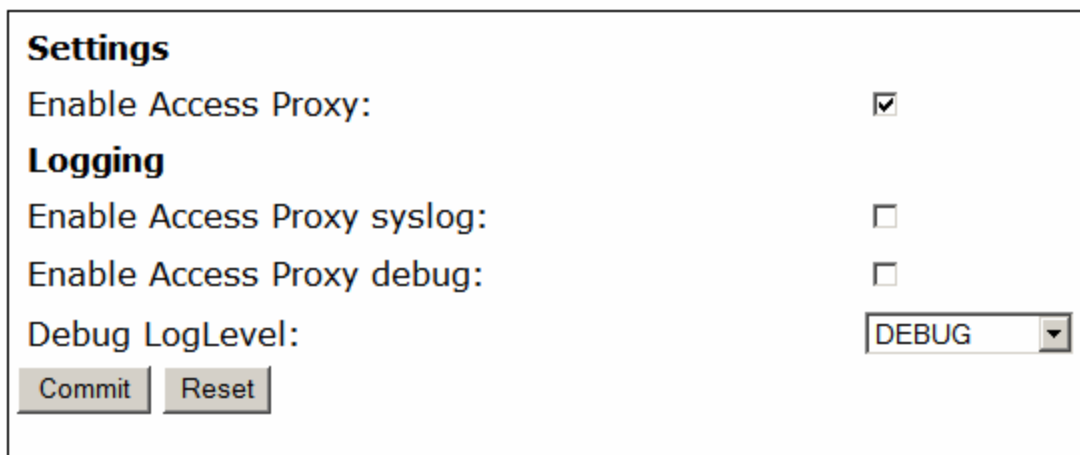
- 4596 – Access Proxy – Continuing to enhance the support for multiple clients that are installed behind SoHo or enterprise NAT devices. Issues have been found in the field in previous versions that cause the Access Proxy to not correctly track clients that are installed behind devices that can NAT a single client as multiple IPv4 addresses and may cause the client to display “Can’t connect to Presence server” Added syslog message for deleting client when iptables rules are not added.
 - 5530 – Modification made to the access proxies add client, delete client and the clients list clean up process which allows the mobile user to switch network interfaces immediately without experiencing re-authentication issues.
- 4599 – AccessProxy - Logging enhancement - Access Proxy now has a GUI item to enable debug messages for advanced troubleshooting.

The output of this debug will be only accessible from the CLI interface in the /var/log/ directory as accessproxy.log which is the active file, when this file reaches a 250K size it will be rotated to accessproxy.log.1. The logs will continue to rotate up to accessproxy.log.7 and then be rotated out and non recoverable. Depending on the log level selected and the amount of users trying to connect these logs can fill up and rotate within 1min.

Added basic Access Proxy message decode to syslog; this feature will provide some information to help solve connection related issues. By enabling Access Proxy syslog the system will send limited messages to the systems logging application; you can access these files on the CLI in the /var/log directory as messages and messages.old. Local syslog files are limited to 32k. If you wish to capture syslog on a remote syslog server configure the Remote Syslog Host and Enable Remote System Logging in the Service Configuration page on the GUI.

Added help text for new logging options.
