Polycom[®] RealPresence[®] Group Series

Overview

Polycom announces a new release of Polycom® RealPresence® Group Series software. This document provides the latest information about the following Polycom software:

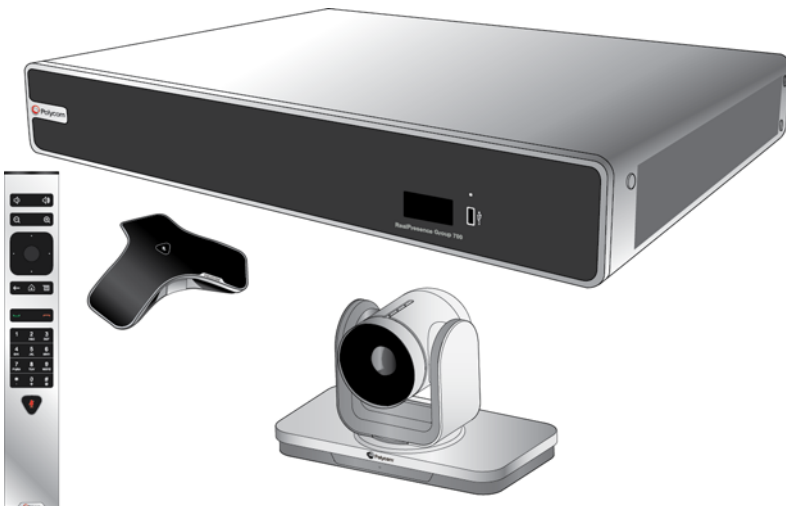
RealPresence Group 700 system and accessories

RealPresence Group 700 systems ship with a Polycom EagleEye IV camera, a RealPresence Group Microphone Array, and a RealPresence Group Remote Control.
