Polycom® RealPresence® Collaboration Server 1800/2000/4000/Virtual Edition

Polycom announces the release of the Polycom® RealPresence® Collaboration Server 8.7.4 software. This document provides the latest information about this release.

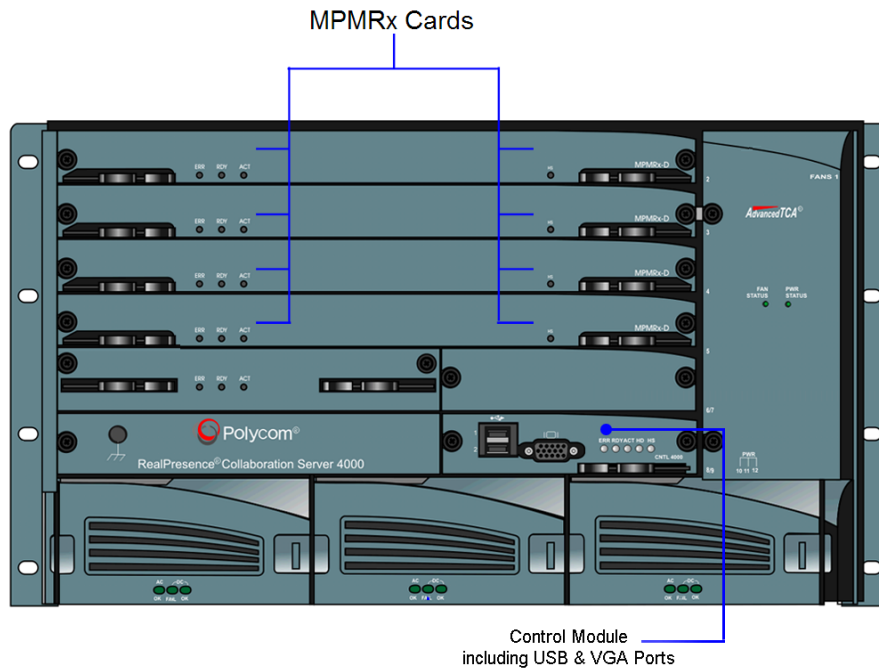
The RealPresence Collaboration Server (RMX) 2000/4000 must be used with the correct software version. Both Control Modules BRD2534B-L0/BRD2535B-L0 include USB and VGA ports on the front panel.

RMX 4000 system with CNTL 4000 Module BRD2535B-L0
