Polycom® RealPresence® Collaboration Server (RMX®) 1800/2000/4000

Polycom announces the release of the Polycom RealPresence® Collaboration Server (RMX) version 8.6.7 software. This document provides the latest information about this release.

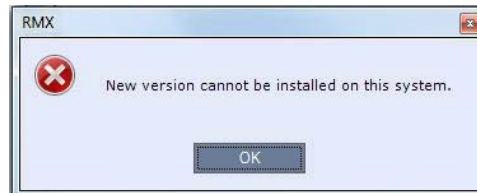
If the upgrade is not a supported upgrade path, the system will sound an alarm and an error message will appear.

When you acknowledge the error, the installation is aborted, and because the Safe Software Version Installation warning has been activated, your current browser session will block any new installation attempt. This applies to all software versions, except for version 7.6 which will still allow system downgrades.

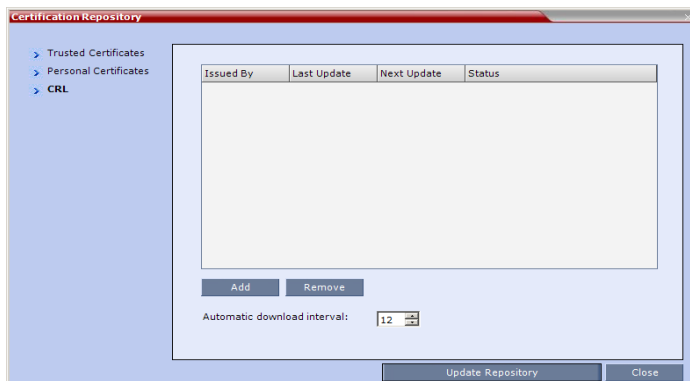
- A CRL is automatically installed when the administrator installs a CA that has an existing CDP.
- Manual installation of CRLs is supported as in previous versions.
- The MCU will always use the latest CRL if a conflict should arise.
- The automatic CRL download procedure is run after every system reset. A CRL will only be downloaded if it supersedes the current CRL.
- An Automatic Download Interval can be specified in the **Certification Repository - CRL** dialog.

- The Automatic Download Interval range is 0-168 hours, the default is 12. A value of 0 disables automatic CRL download.

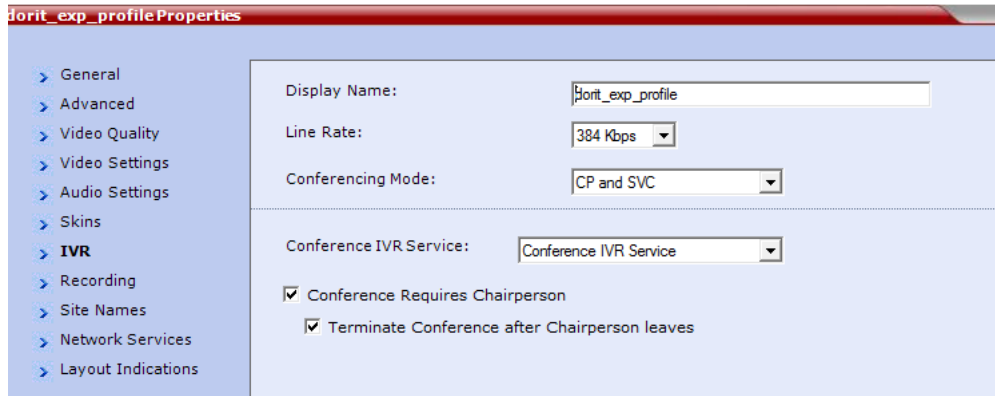
- The conference begins upon first chairperson connecting (first check-box).

- The conference terminates upon last chairperson disconnecting (second check-box).

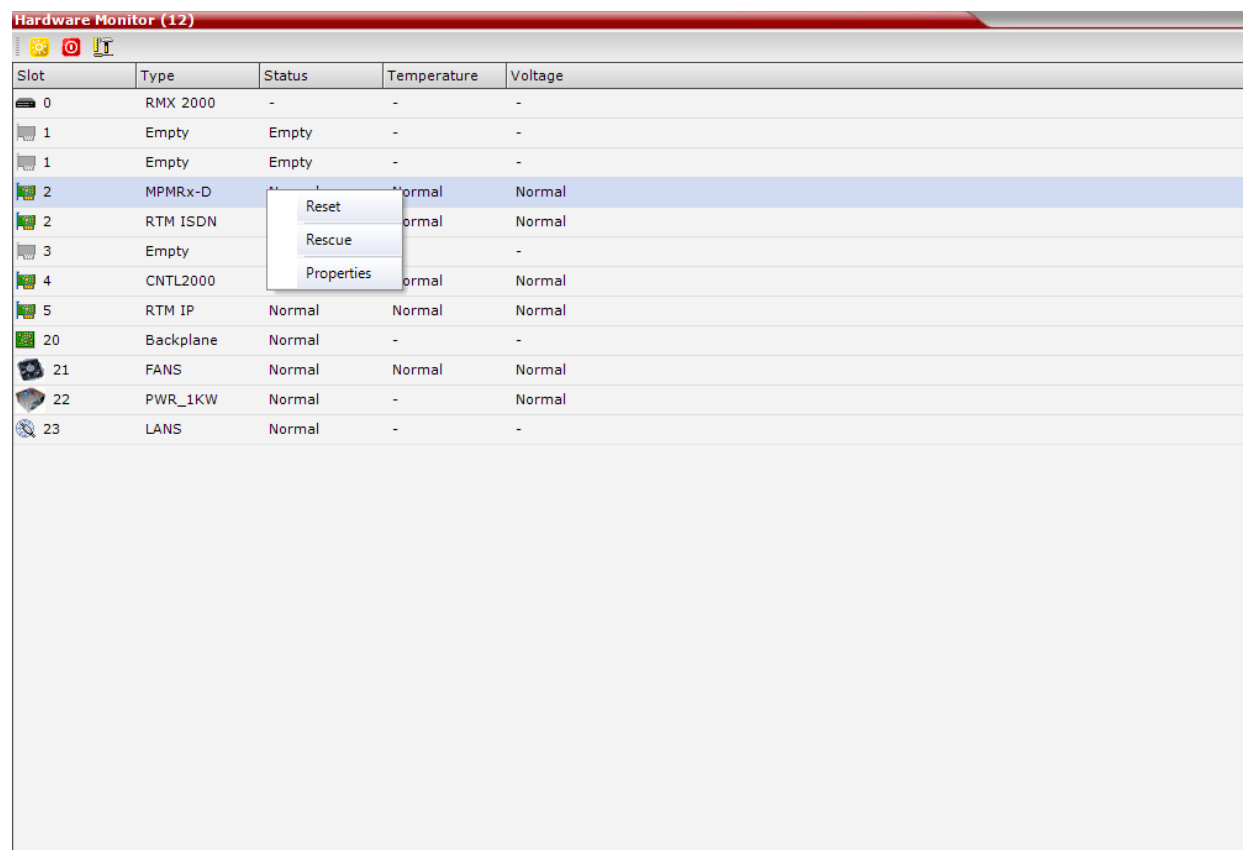
Only users with Support permission can reset an MPMRx Media card.

The card reset process is performed within two minutes.

Slot	Type	Status	Temperature	Voltage
0	RMX 2000	-	-	-
1	Empty	Empty	-	-
1	Empty	Empty	-	-
2	MPMRx-D	Normal	Normal	Normal
2	RTM ISDN	Normal	Normal	Normal
3	Empty	-	-	-
4	CNTL2000	Normal	Normal	Normal
5	RTM IP	Normal	Normal	Normal
20	Backplane	Normal	-	-
21	FANS	Normal	Normal	Normal
22	PWR_1KW	Normal	-	Normal
23	LANS	Normal	-	-

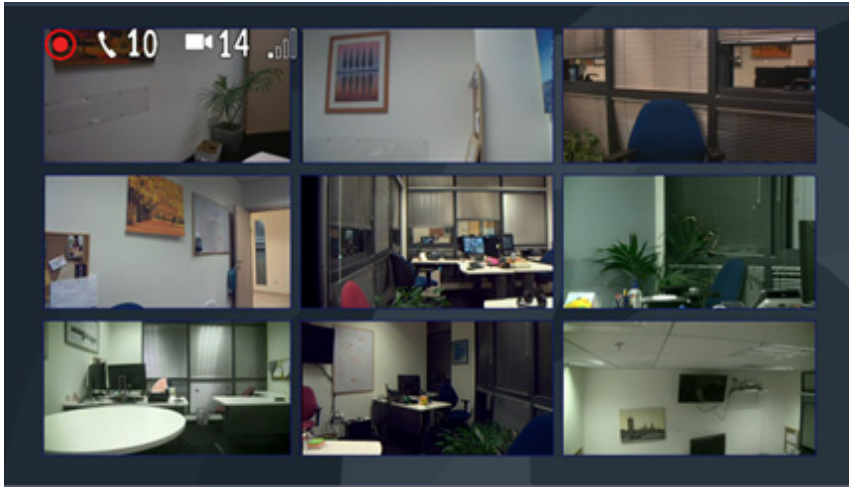
The video participant is adjacent to the indications for recording, audio participants, and network quality. These indications are ordered from the outside, towards the inside, in the order:

- Recording indication
- Audio participant indication
- Video participant indication
- Network quality indication

Below, is an example of the layout indication order, when all indication types are selected.
