**Release Notes**  
**Polycom® Video Border Proxy**  
**(VBP™) VOS Version 11.2.3**

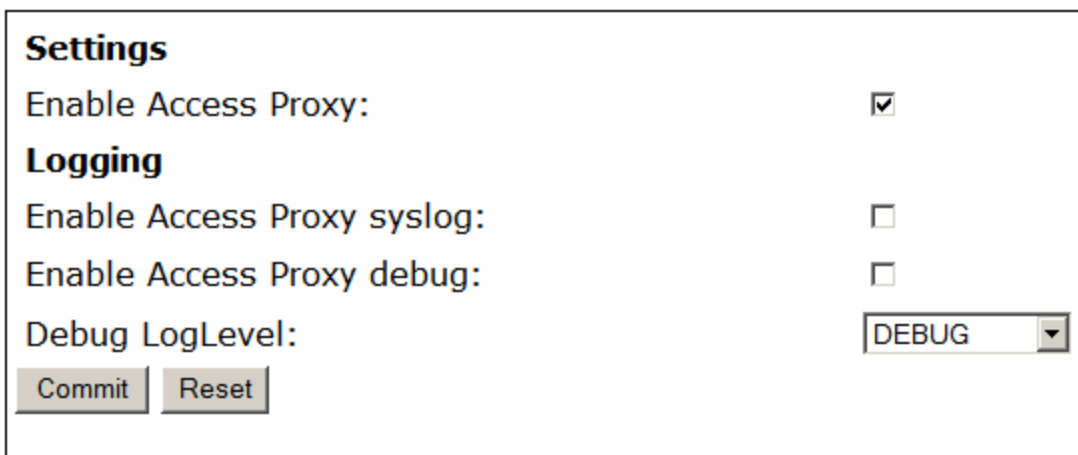
Added basic Access Proxy message decode to syslog; this feature will provide some information to help solve connection related issues. By enabling Access Proxy syslog the system will send limited messages to the systems logging application; you can access these files on the CLI in the /var/log directory as messages and messages.old. Local syslog files are limited to 32k. If you wish to capture syslog on a remote syslog server configure the Remote Syslog Host and Enable Remote System Logging in the Service Configuration page on the GUI.

The screenshot shows a GUI settings window with the following content:

- Settings**
- Enable Access Proxy:
- Logging**
- Enable Access Proxy syslog:
- Enable Access Proxy debug:
- Debug LogLevel:
- Buttons: Commit, Reset
