Polycom® CX5100 and CX5500 Unified Conference Stations for Microsoft® Lync®

Polycom announces the release of software version 1.1.5 for the Polycom CX5100 and CX5500 Unified Conference Stations for Microsoft Lync. This document provides the latest information about the Polycom CX5100 and CX5500 systems.

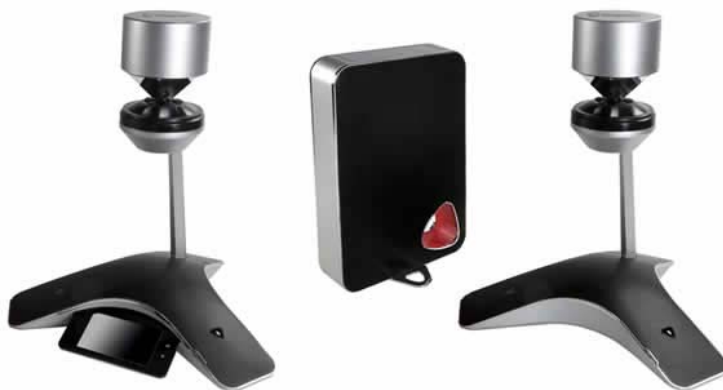
Polycom CX5500 and CX5100 Unified Conference Stations for Microsoft Lync

The Polycom CX5100 and CX5500 Unified Conference Stations enable you to use the collaboration capabilities of Microsoft Lync voice, video, and content while automatically tracking the flow of conversation to support richer, more interactive communication. The following figure shows the CX5500 tabletop unit with LCD panel, the CX5100 tabletop unit, and the power data box for both systems.

During a call, the integrated cameras capture the active speaker as well as the entire panoramic view of your conference room, and the integrated microphones capture the voices coming from any location around the table. For larger conference rooms, you can add optional satellite microphones.
