Polycom® CX5100 and CX5500 Unified Conference Stations for Microsoft® Lync®

Polycom announces the release of version 1.1.1 software for the Polycom CX5100 and CX5500 Unified Conference Stations for Microsoft Lync. This document provides the latest information about the Polycom CX5100 and CX5500 systems.

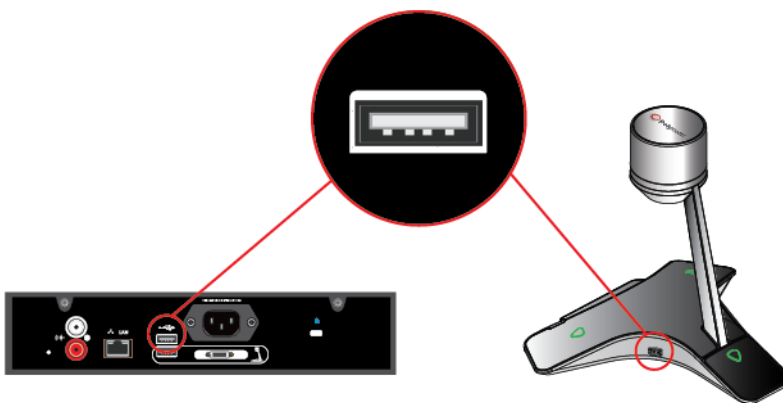
Location of USB 2.0 ports on tabletop unit and on power data box

The location of the ports is shown in the following diagram.
