Polycom® CX5100 and CX5500 Unified Conference Stations for Skype for Business

Polycom announces the release of version 1.3.4 software for the Polycom CX5100 and CX5500 unified conference stations for Microsoft Lync and Skype for Business. This document provides the latest information about the Polycom CX5100 and CX5500 systems.

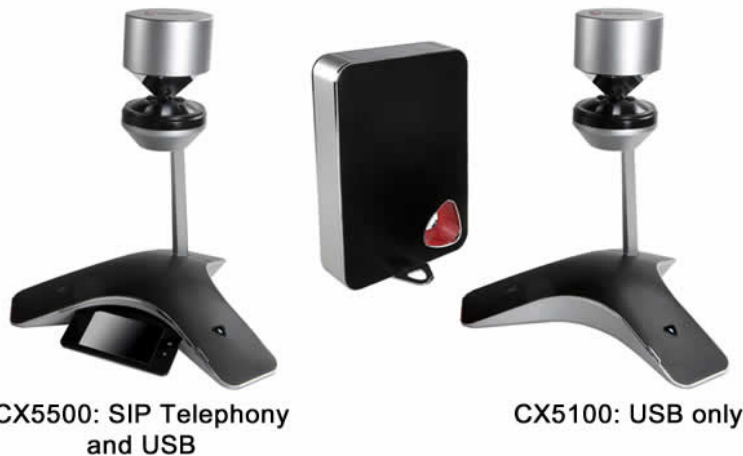
The Polycom CX5100 and CX5500 unified conference stations enable you to use the collaboration capabilities of Microsoft Lync or Skype for Business voice, video, and content while automatically tracking the flow of conversation to support richer, more interactive communication. The following figure shows the CX5500 tabletop unit with LCD panel, the Polycom CX5100 tabletop unit, and the power data box for both systems.

Polycom CX5100 and CX5500 unified conference stations for Microsoft Lync or Skype for Business

During a call, the integrated cameras capture the active speaker as well as a panoramic view of your conference room, and the integrated microphones capture the voices coming from any location around the table. For larger conference rooms, you can add optional satellite microphones.

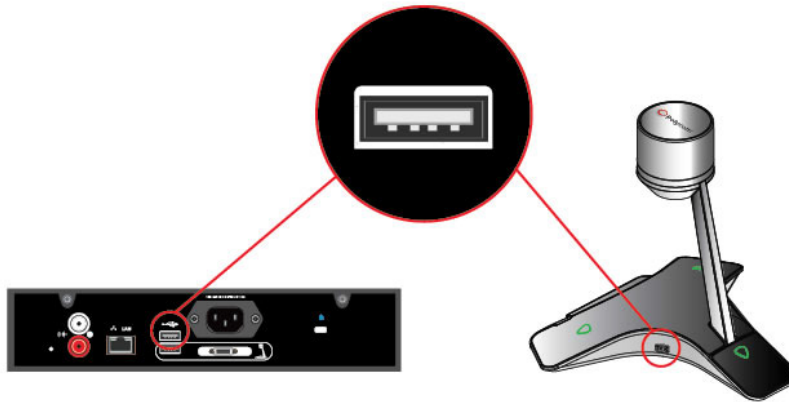
- 1 Format a USB flash drive as FAT32. Polycom recommends that you use a USB 2.0 flash drive.
If you are using a drive that is already formatted, ensure that you delete previous software updates from the flash drive.
- 2 From the Polycom Support site, download the software package to the flash drive. The software package has a .tar extension.
- 3 Connect the USB flash drive to the USB 2.0 port on the tabletop unit or on the power data box. If you choose to connect to the power data box, first remove the rubber plug from the USB port.
The locations of the ports are shown in the following diagram.

- 4 On the Polycom CX5500 system, respond to the software update request that displays on the LCD touch screen.
The system detects the flash drive and starts the update within 30 seconds. The indicator lights begin to flash, indicating that the update has started.
The system reboots several times during the update. The indicator lights flash in several different patterns.
The update is complete when the indicator lights stop flashing.
