Polycom® CX5100 and CX5500 Unified Conference Stations for Microsoft® Lync®

Polycom announces the release of version 1.1.2.1 software for the Polycom CX5100 and CX5500 Unified Conference Stations for Microsoft Lync. This document provides the latest information about the Polycom CX5100 and CX5500 systems.

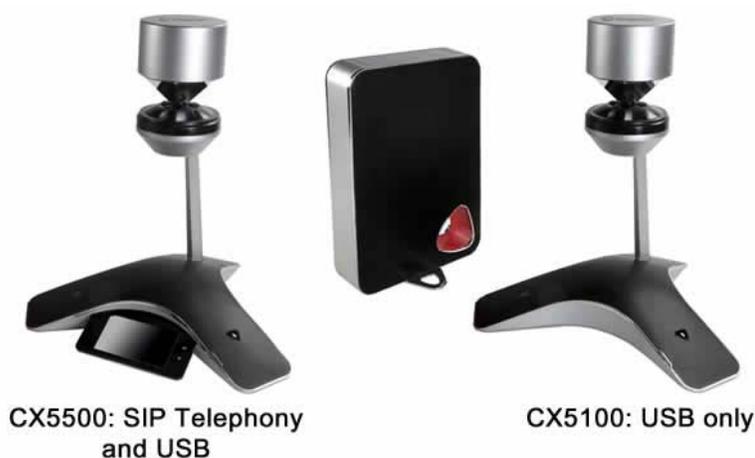
The Polycom CX5100 and CX5500 Unified Conference Stations enable you to use the collaboration capabilities of Microsoft Lync voice, video, and content while automatically tracking the flow of conversation to support richer, more interactive communication. The following figure shows the CX5500 tabletop unit with LCD panel, the CX5100 tabletop unit, and the power data box for both systems.

Polycom CX5500 and CX5100 Unified Conference Systems

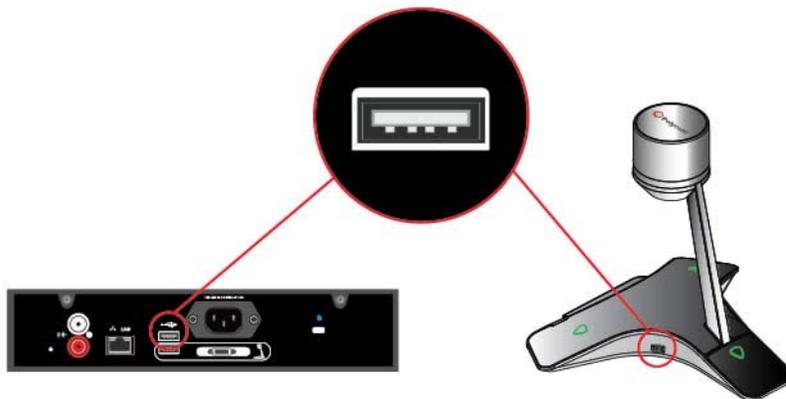
- 1 Format a USB flash drive as FAT32.
If you are using a drive that is already formatted, ensure that previous software updates are deleted from the flash drive.
- 2 From the Polycom Support site, download the software package to the flash drive. The software package has a .tar extension.
- 3 Connect the USB flash drive to the USB 2.0 port on the tabletop unit or on the power data box. If you choose to connect to the power data box, first remove the rubber plug from the USB port.
The locations of the ports are shown in the following diagram.

Locations of USB 2.0 ports on tabletop unit and on power data box

Category	Issue ID	Found in Release	Description	Workaround
USB	MIL-1039 VIDEO-109583	1.0.0	On rare occasions, the CX5100 system is not detected as a USB device after the CX5100 system or the computer is restarted.	Try the following solutions: <ul style="list-style-type: none"> • Disconnect the USB cable from the computer and reconnect it. • Disconnect power from the CX5100 system and then reconnect it. • Update the USB 3.0 driver on the computer to ensure that the date of the driver is 2013 or later. For the latest driver, check the web site of your computer's manufacturer.
USB	MIL-1021 VIDEO-109535	1.0.0	The computer might sometimes incorrectly identify the CX5100 system as a USB 2.0 device.	Try the following solutions: <ul style="list-style-type: none"> • Ensure that the system is connected to a USB 3.0 port. A USB 3.0 port is usually blue with an SS icon next to the port. • Disconnect the USB cable from the computer and reconnect it. • Update the USB 3.0 driver on the computer to ensure that the date of the driver is 2013 or later. For the latest driver, check the web site of your computer's manufacturer. • Connect the computer directly to the blue USB 3.0 port on the power data box instead of the tabletop unit.
