Polycom® SoundStation Duo™ Support Restrictions in UC Software 4.0.1

This engineering advisory provides information about support restrictions for certain Polycom® SoundStation Duo™ conference phones that have been upgraded to Polycom UC Software (UCS) 4.0.1.

This engineering advisory applies to SoundStation Duo phones with hardware revision F or later.

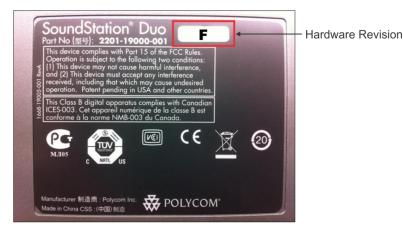
The phone's hardware revision is on the back of the phone, above the barcode label and next to the serial number, as shown next. It is a single capital letter.
